ENGINEERING REPORT

**Project:** Kellen Grade Stabilization Structure

**Location:** Big Stone County, Minnesota

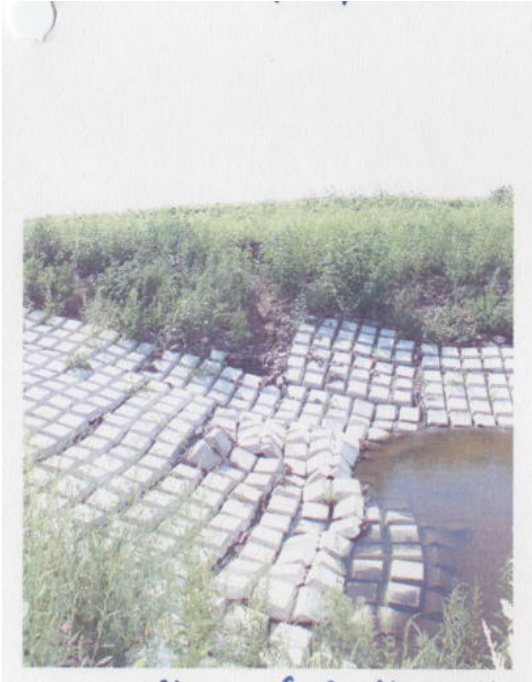
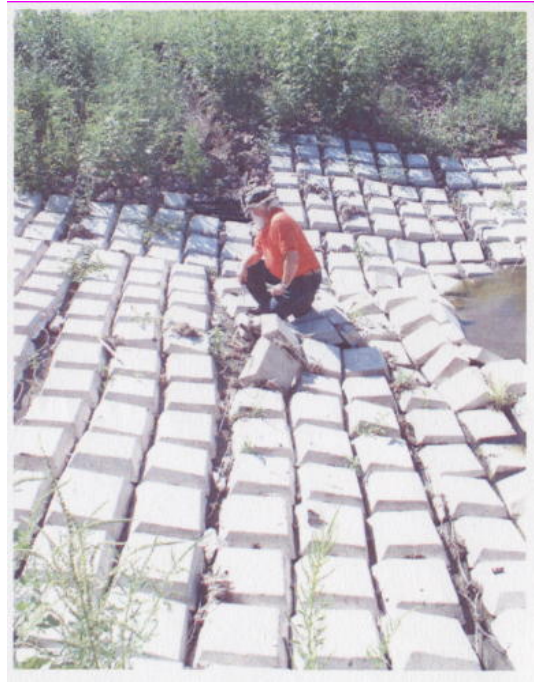
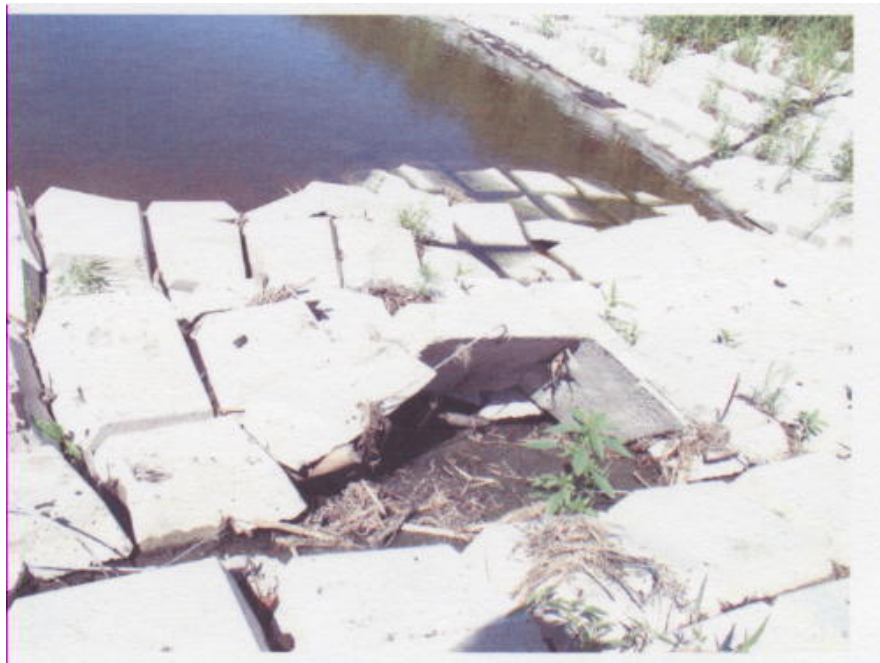
- **2005 Damage.** Photos of the 2005 failure show an uneven surface of the blocks downstream of the uplifted mat edge. It appears that the blocks had lifted during the event and were deposited haphazardly afterwards. As evidence by the gaps between mats, it appears that the mats slid downstream.

June, 2005 Block Movement

Repair of the chute was performed by NRCS and SWCD personnel and consisted of dragging the mats back up into position and adding the additional anchors and clamps.

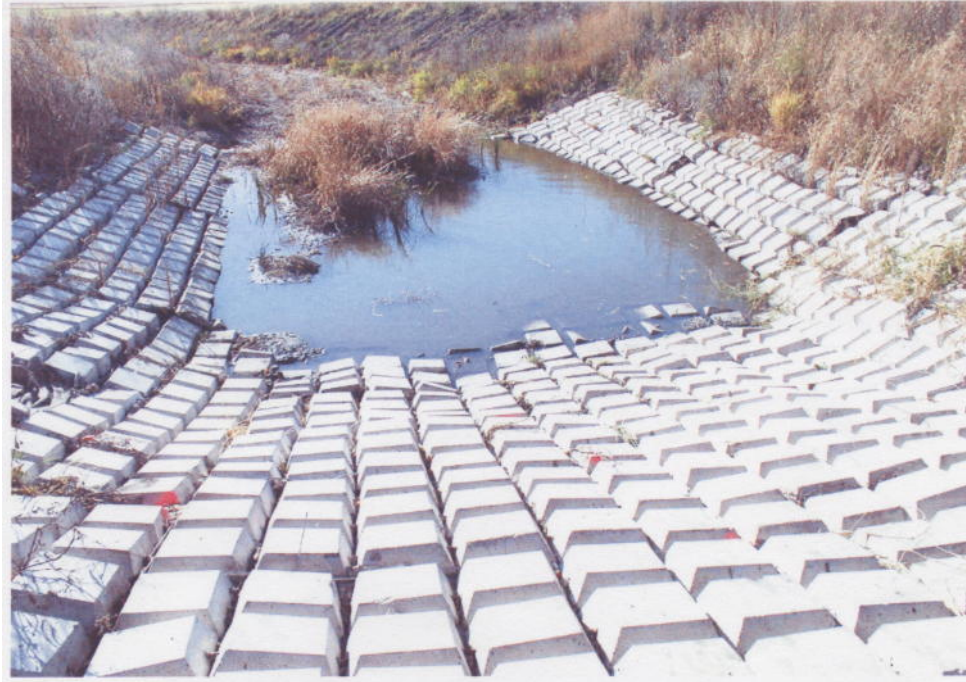
November, 2005  
Repaired Chute after June, 2005 Damage

Referring to the above picture, the repaired surface after the 2005 event does not appear uniform. Blocks near the end of the chute appear uneven with some blocks tilting and projecting above the desired uniform plane formed by the tops of correctly placed blocks. This suggests that some movement of the subbase took place and that when the blocks were dragged back into position they conformed to the altered subbase. Water forces on these block protrusions greatly effect the stability of the blocks.

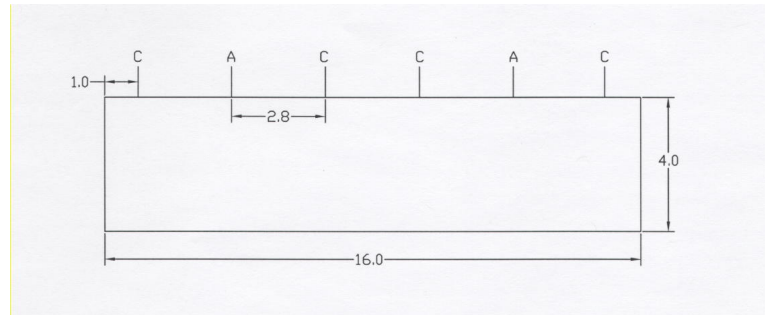
Assumed Clamp/Anchor Pattern per Drawings

A gap of 2.8 feet between clamps or anchors results in approximately every other block. In observing the uplifted mat in the 2005 event, it appears that an anchor or clamp was missing or that the placement resulted in a greater gap.

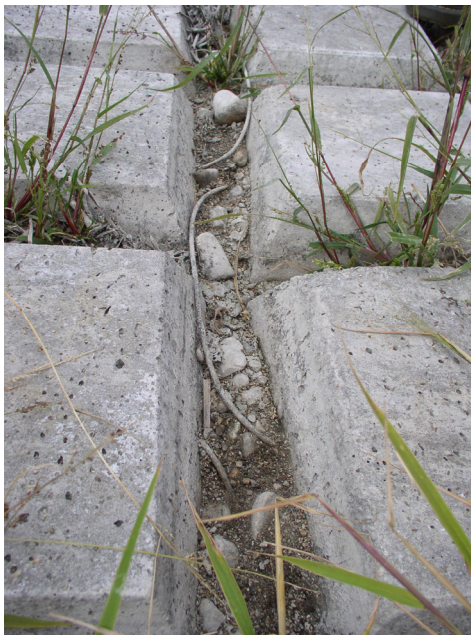
There were many other locations where additional clamps or anchors could have been used to secure the mats together. The prescribed clamping pattern allowed slack to develop in the system allowing mats to move.

Potential Clamp/Anchor Location

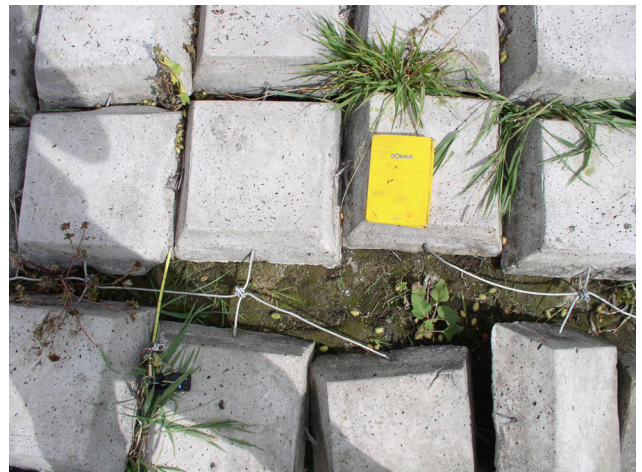
Block Movement and Potential  
Clamp/Anchor Location

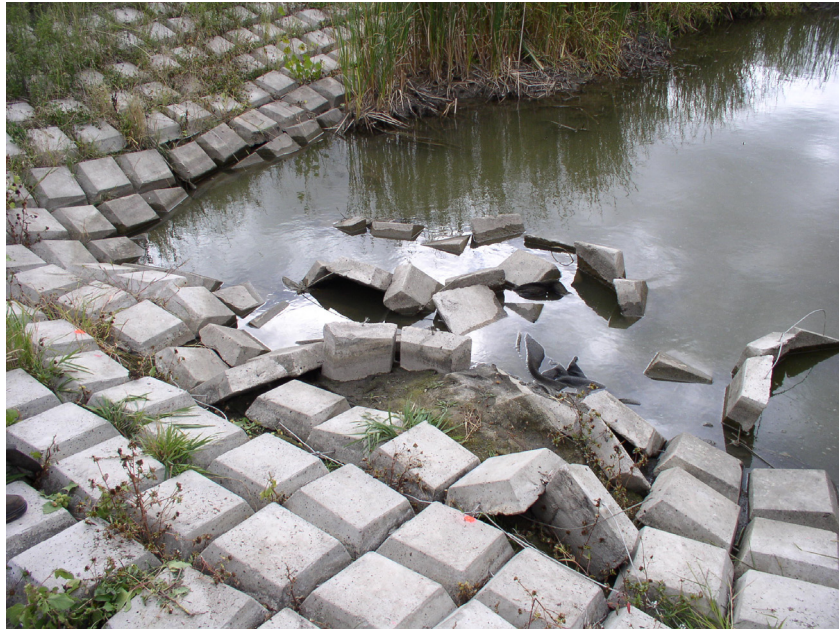
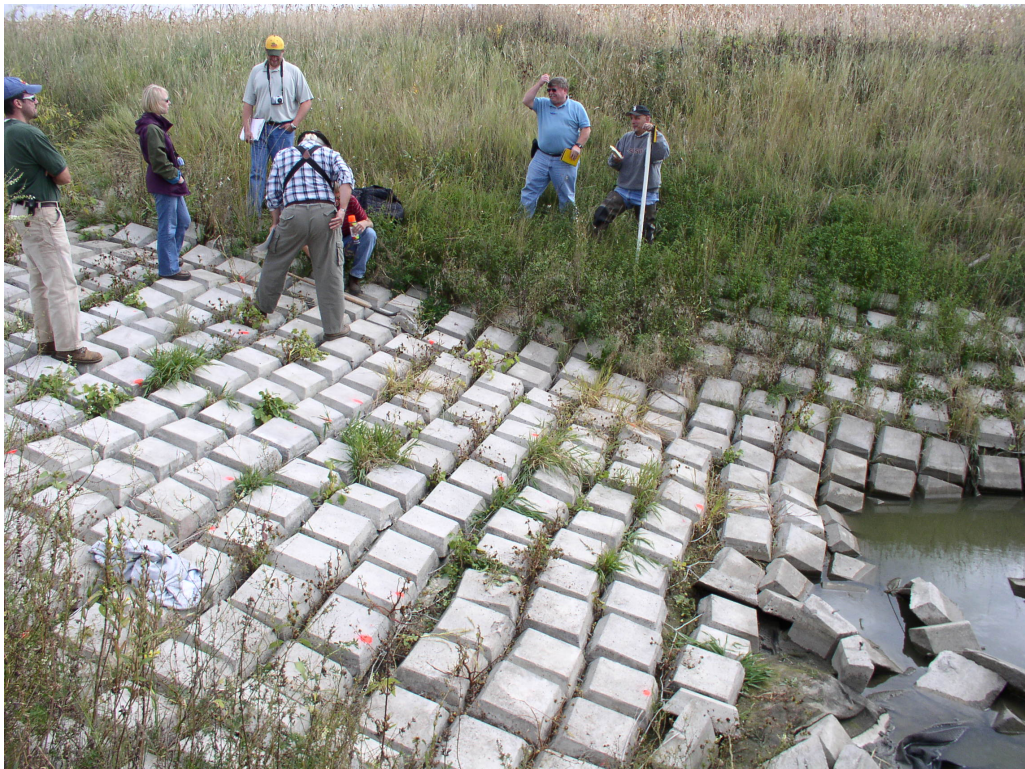
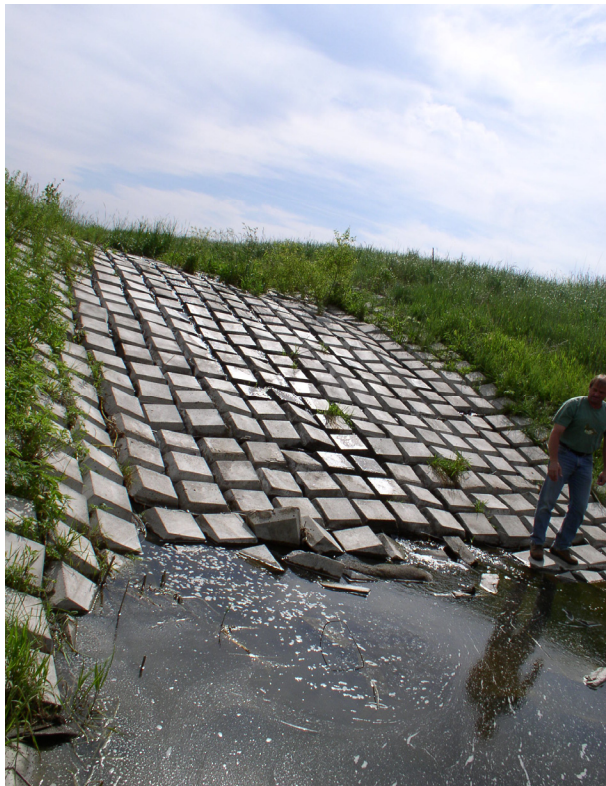
- **2008 Damage.** The current condition of the chute as caused by the June, '08 flow event is much worse than that from the '05 event. The displacement of the blocks is much greater and some of the 3/16" stainless steel cables connecting the blocks broke. Many of the blocks in the center, lower ¼ of the chute and in the upstream end of the stilling basin have been disturbed.

2008 Displaced Blocks

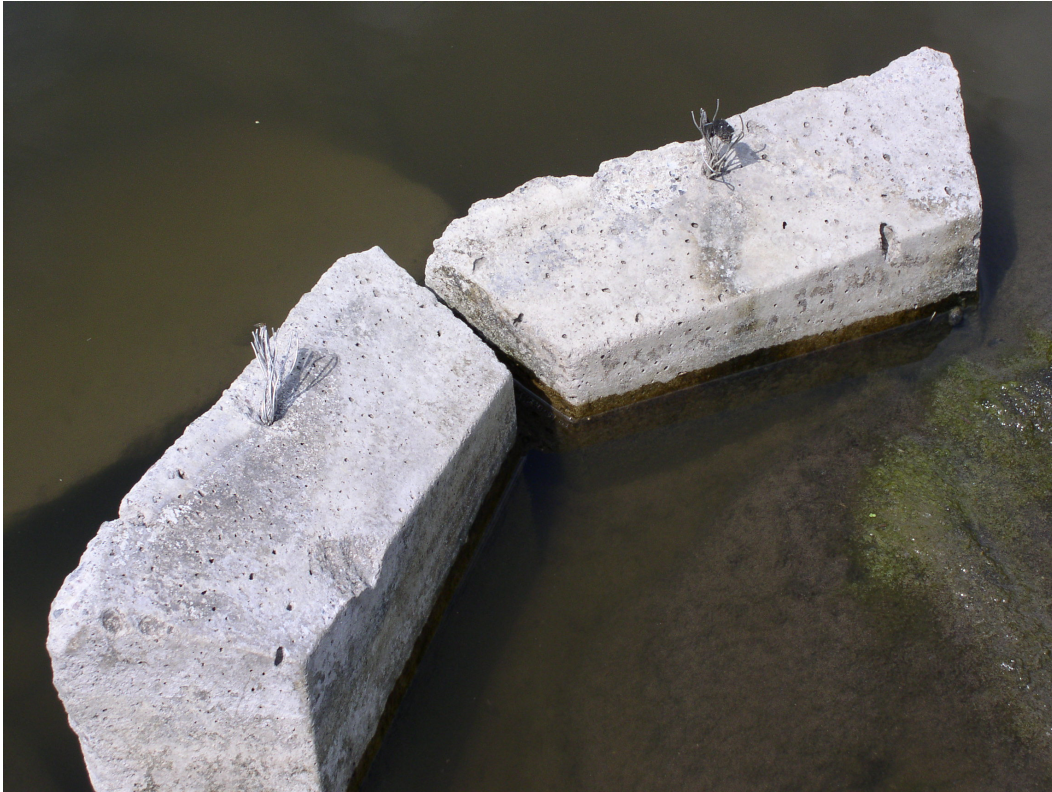
Blocks. In place blocks measured 4.5" high. Block literature classifies the blocks as CC35 blocks. The concrete blocks appeared to be in good shape. The stainless steel cables were measured at 3/16" in diameter and were properly centered in the concrete blocks. Many of the cables in the displaced blocks were broken. The broken cables were frayed.

2008 Displaced Blocks,  
Broken Stainless Steel Cables

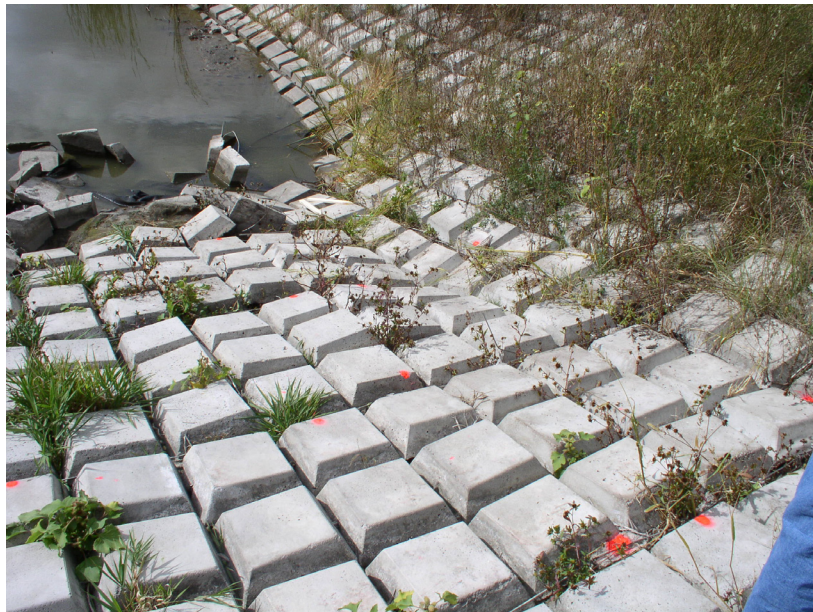
Using a tile probe, approximately three inch deep voids were found under the blocks and geotextile inside of the toes of the chute. These voids started approximately  $\frac{1}{4}$  of the way down the chute and extended to the chute bottom.

2008 Displaced Blocks  
Subsidence along RDS toe

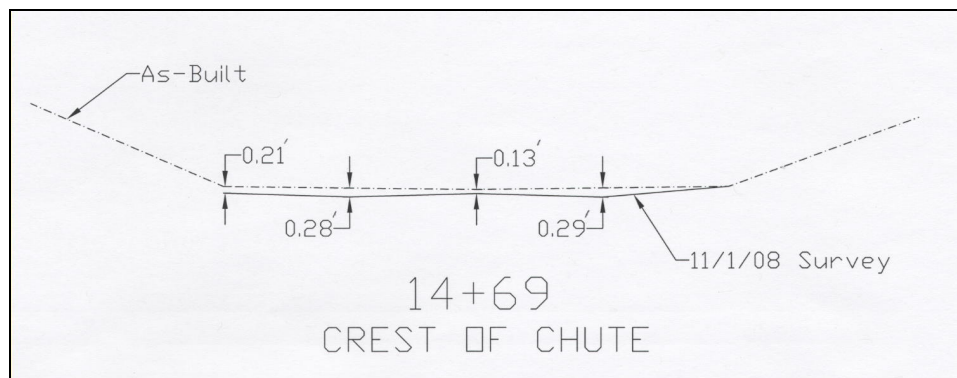
A cross section of the chute crest was surveyed and plotted with the as built survey. The site's TBM could not be found so the plotted cross section was adjusted in elevation so that its high point matched the as-built elevation at that point.

The survey documents what was visually apparent, that the crest was not even. The crest had subsided in areas.
